Satellite-Based Damage Assessment of Affected Villages in Maungdaw District

(Assessment based on satellite imagery recorded on the morning of 22 October 2016)

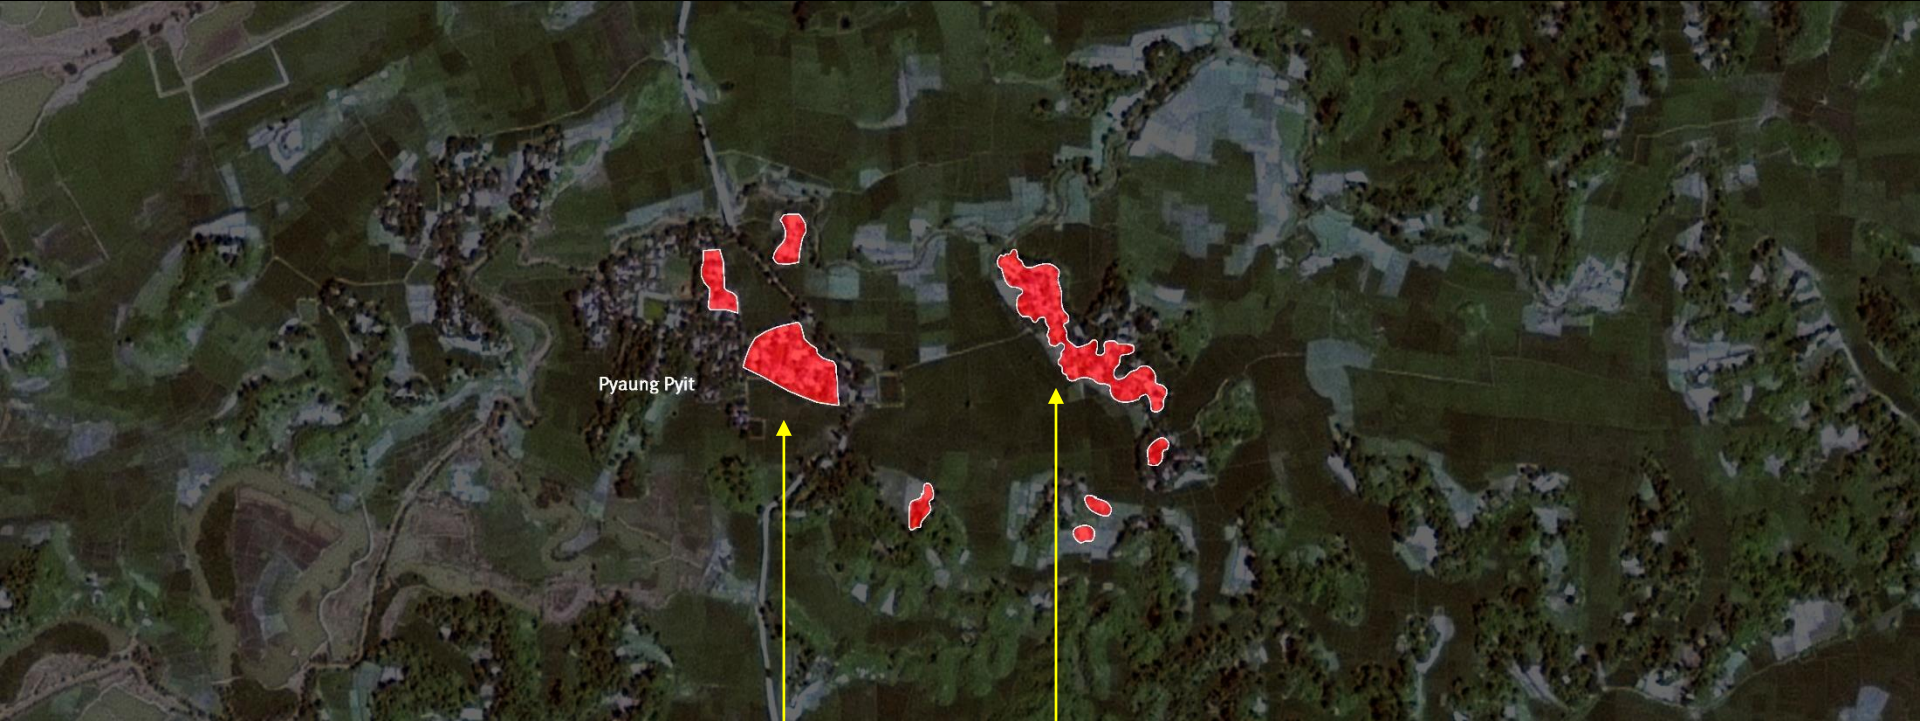
Probable areas of building destruction in the village of Pyaung Pyit, Ngar Sar Kyu, Maungdaw District.

92°20'26.272"E 21°2'47.675"N;
46QDJ3149327444 MGRS

92°20'39.961"E 21°2'47.366"N;
46QDJ3188827433 MGRS

This is a preliminary damage assessment with an associated degree of uncertainty regarding the exact number and extent of building destruction because of limits to the spatial resolution of available satellite imagery and dense tree cover. It is likely that the actual extent of building destruction in Maungdaw has been underestimated. A revised assessment will be conducted once more spatially detailed satellite imagery becomes available. Active fire (thermal anomaly) data collected by SNPP/VIRS satellite sensor.

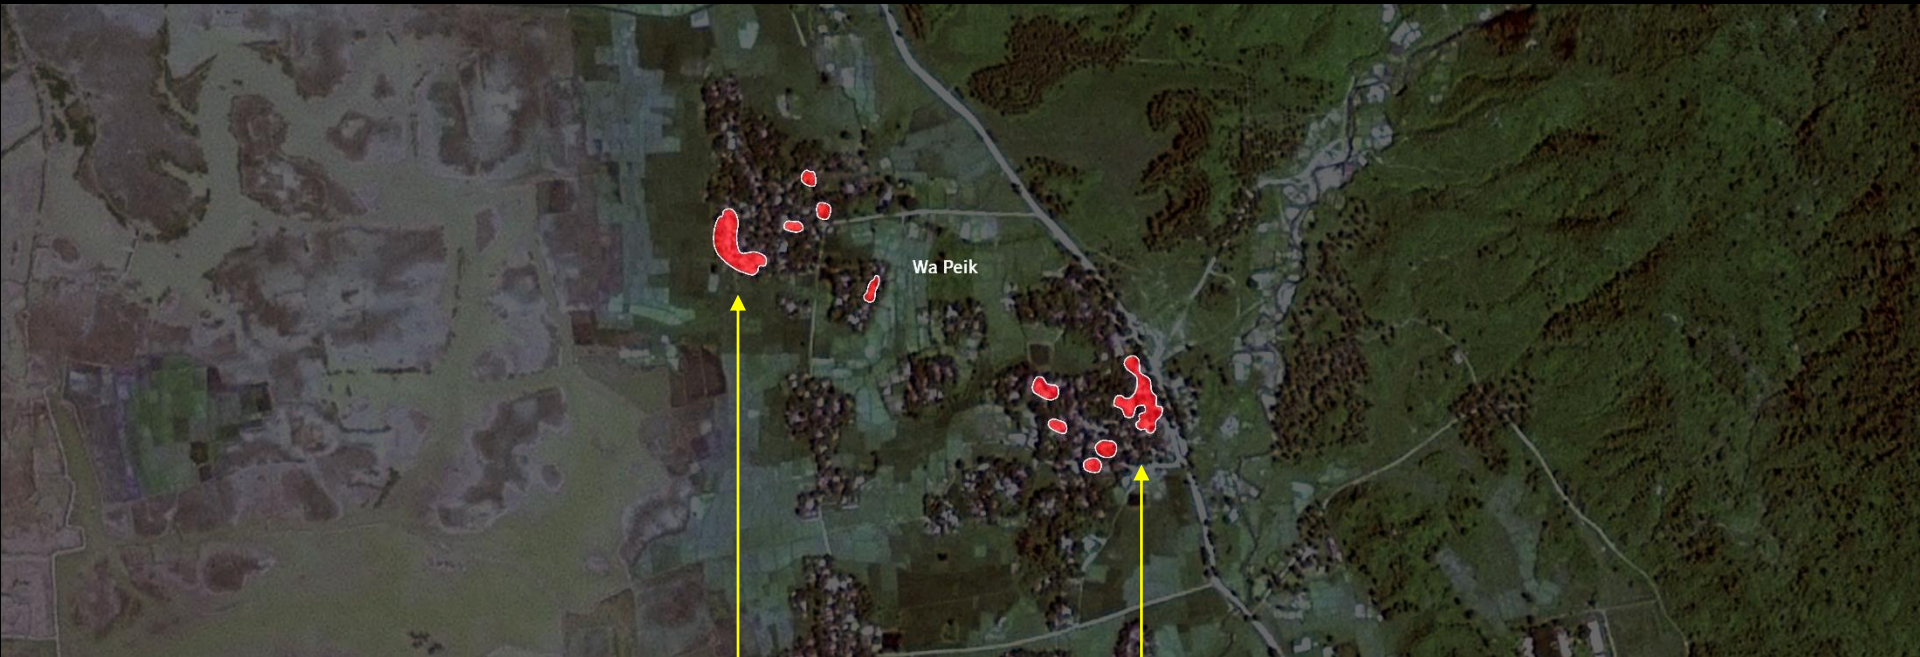
Probable areas of building destruction in the village of Wa Peik, Kye Kan Pyin, Maungdaw District.

92°23'15.995"E 20°55'8.775"N;
46QDJ3633713316 MGRS

92°23'35.766"E 20°55'2.471"N;
46QDJ3690813120 MGRS

This is a preliminary damage assessment with an associated degree of uncertainty regarding the exact number and extent of building destruction because of limits to the spatial resolution of available satellite imagery and dense tree cover. It is likely that the actual extent of building destruction in Maungdaw has been underestimated. A revised assessment will be conducted once more spatially detailed satellite imagery becomes available. Active fire (thermal anomaly) data collected by SNPP/VIIRS satellite sensor.
