SEQUEL EVENT INVESTIGATION

Killed in Mindat Township

Civilians, including children, were allegedly hit with artillery in different incidents

REPORT BY MYANMAR WITNESS, 3 October 2022

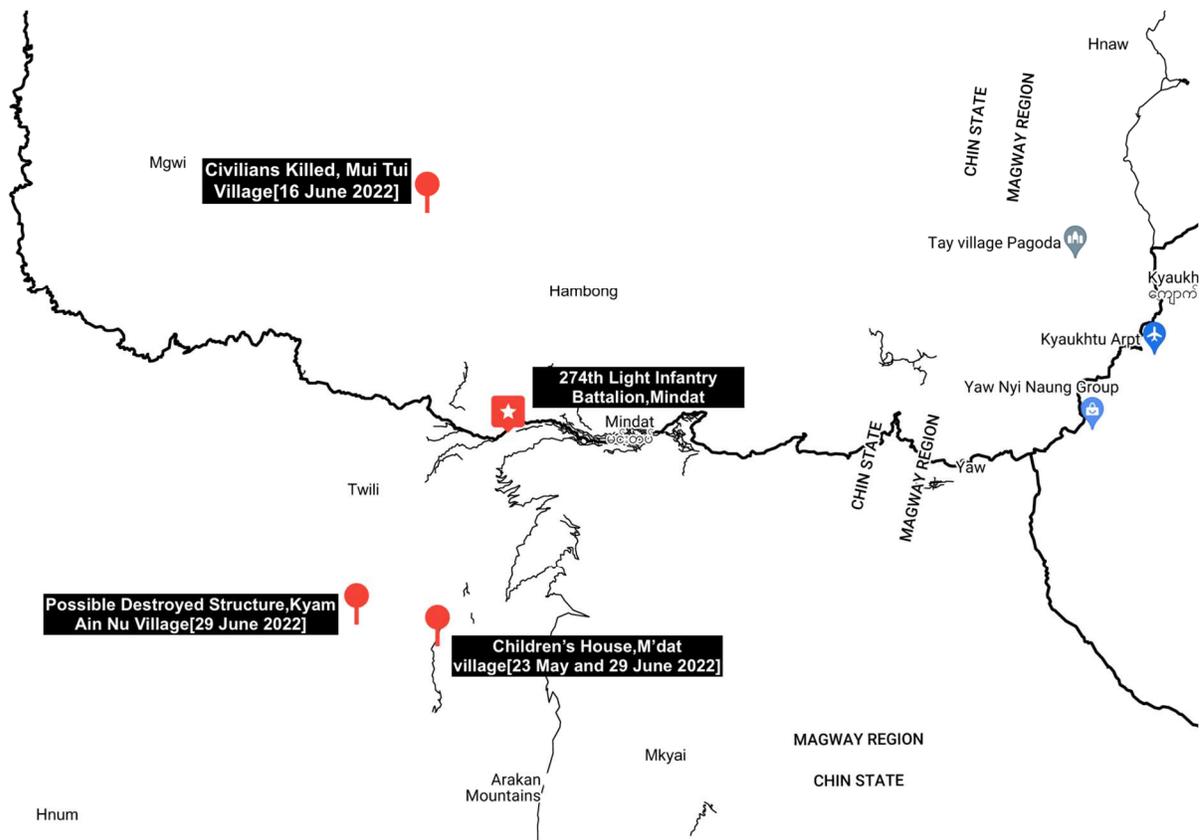
Figure 1: Mapping to demonstrate M'dat (မဒပ်) village, Kyam Ain Nu (ကြာအိမ်နူး) village and Mui Tui (မို့တို့) village in relation to Mindat Township (မင်းတပ်မြို့နယ်) and the LIB 274 base.

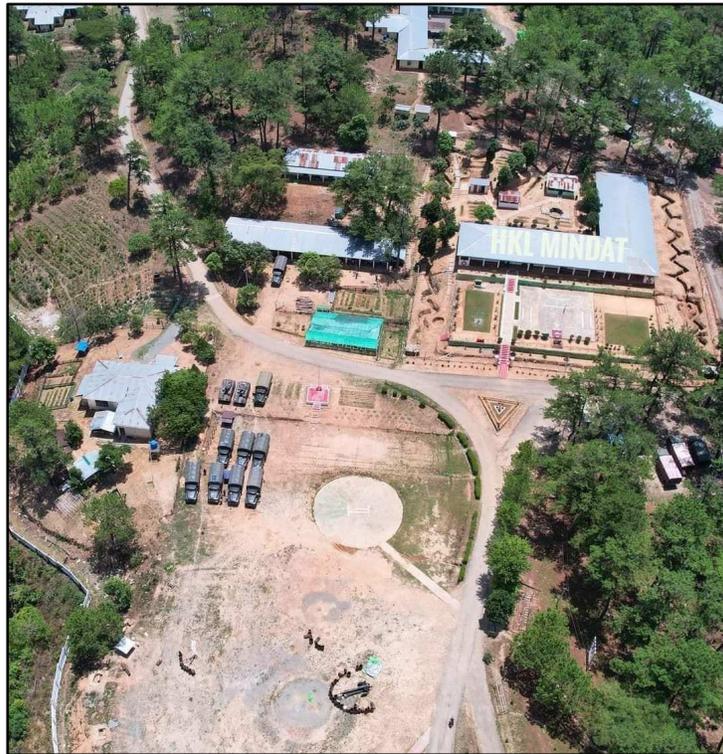
Figure 2: Military convoy stationed at the LIB 274 base.

On 15 May 2022, a drone image of the 274 Light Infantry Battalion military base was posted by [Channel Taunggyi](#) showing a number of military vehicles present at the base. Myanmar Witness geolocated these images to 21.373507, 93.935312, corresponding with the location of the base (Figure 2). There were a number of text reports of military vehicles ([Witness Daily](#), [CDF-Mindat](#)) moving around the area on 15 and 20 May 2022.

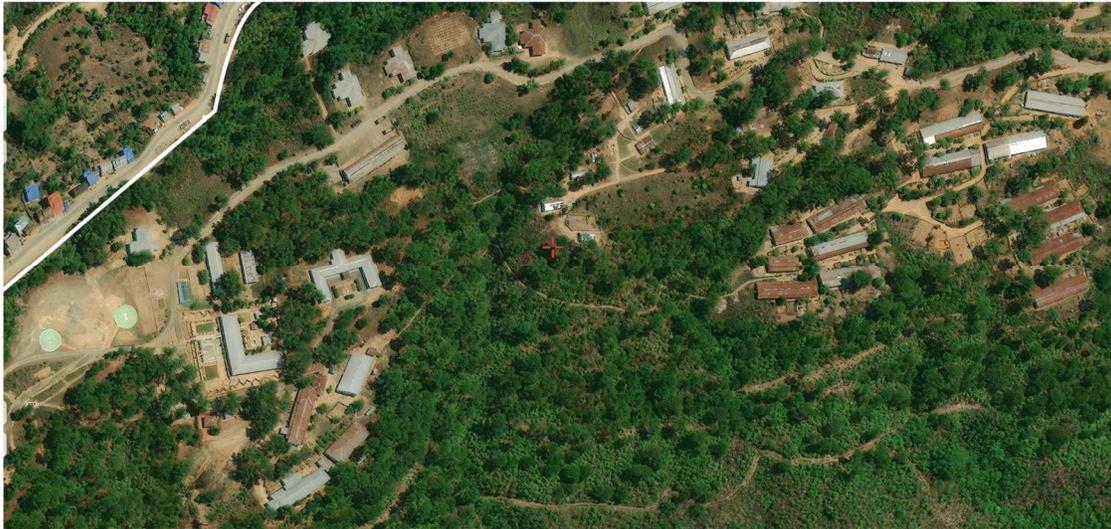
Figure 3: High-Quality Satellite imagery showing the military base of the Light Infantry Battalion 274 in Mindat Township.

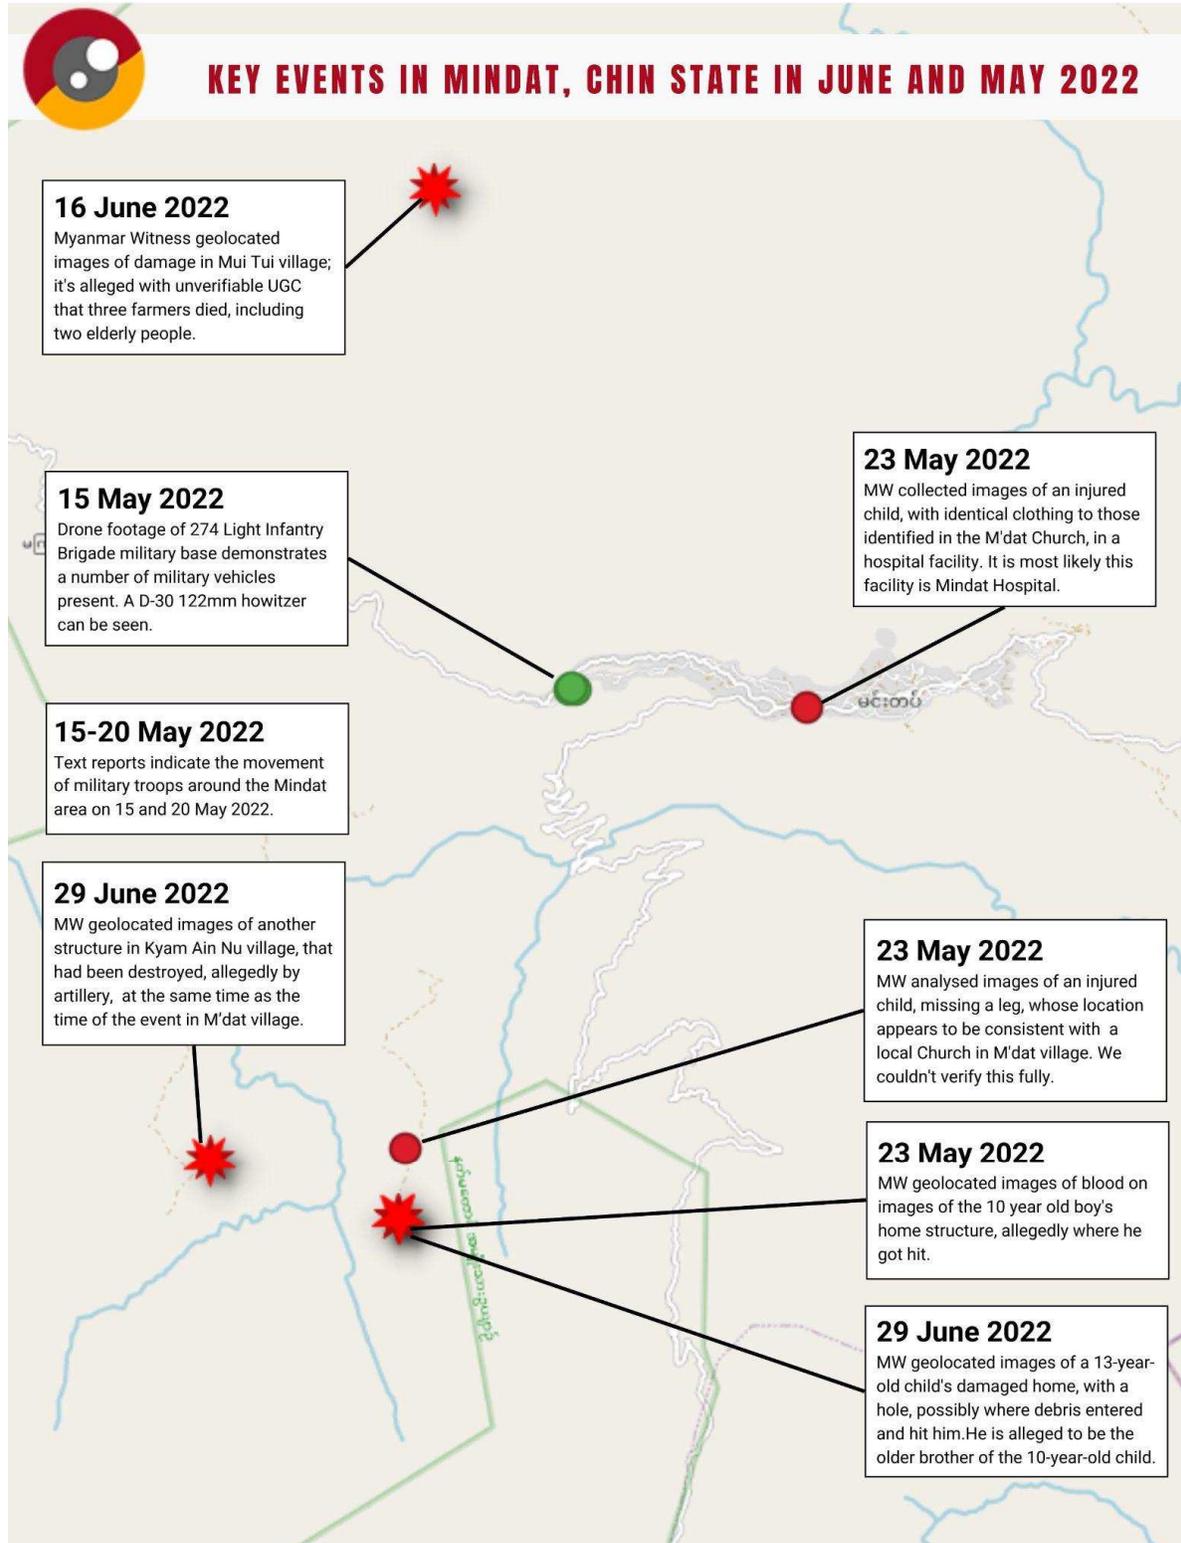
Figure 4: Mapping over [Openstreetmap](#), demonstrating the events recorded by Myanmar Witness to have taken place in Mindat Township (မင်းတပ်မြို့နယ်), Chin State (ချင်းပြည်နယ်) between 15 May - 29 June 2022.

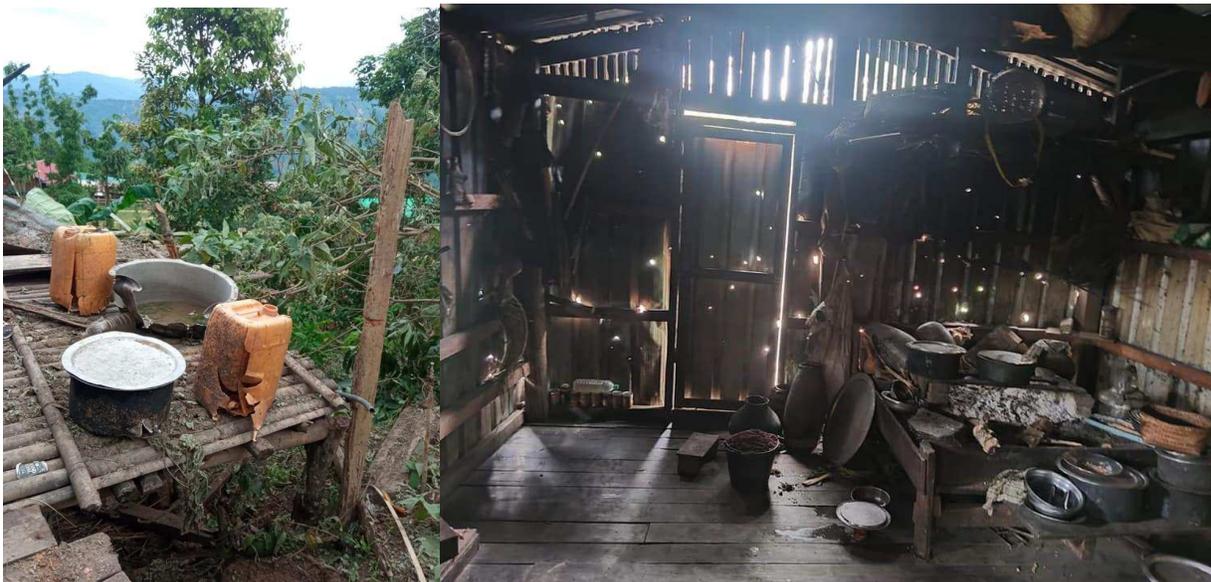
Figure 5: Images uploaded by *The Mindat Post* of homes damaged by alleged artillery shelling.

On the morning of 16 June, [The Mindat Post](#) reported on the destruction of civilian houses in Mui Tui (မို့တို့) village. One of the photos showing a damaged home could be geolocated to the middle of the village [21.429482, 93.919148] (Figure 5, 6 and 7). The destruction was reportedly a result of artillery use by the 274 Light Infantry Battalion.

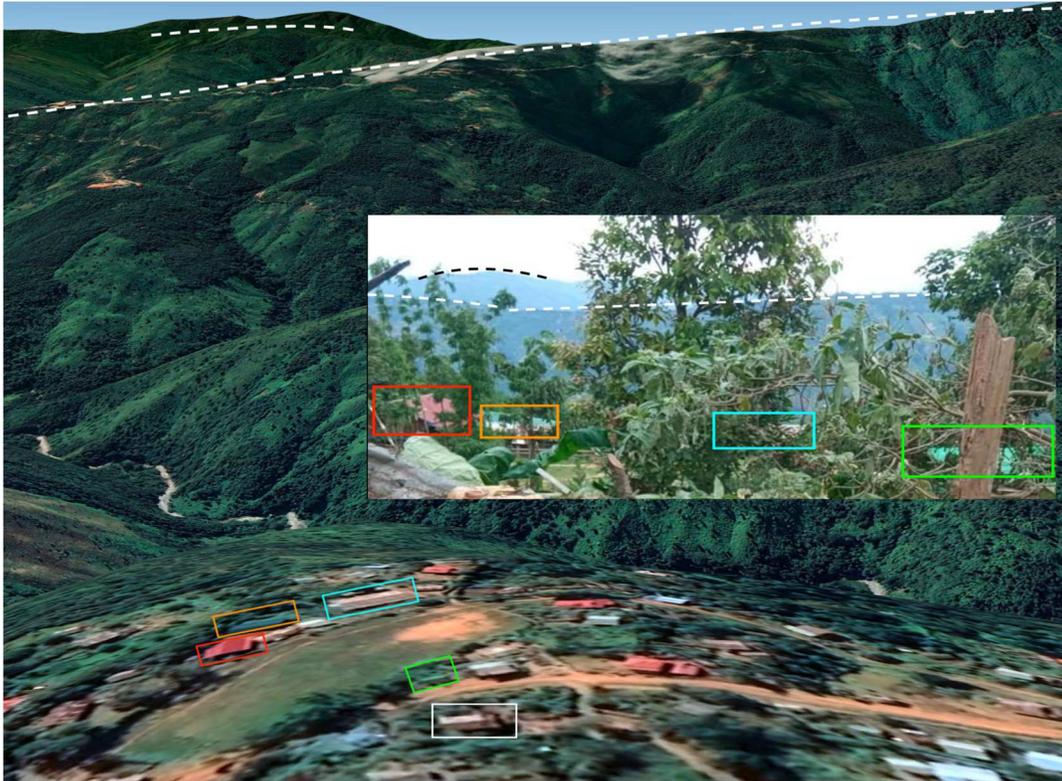
Figure 6: Geolocation of one of the images to Mui Tui (မို့တို့) village at around 21.429482, 93.919148.

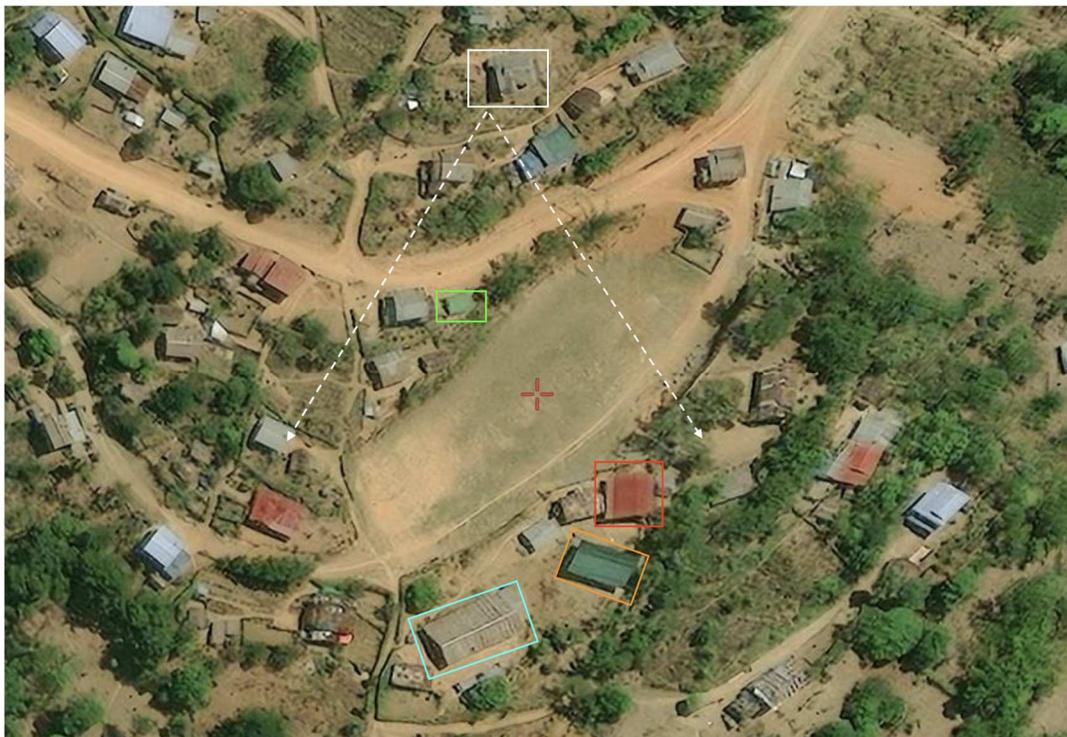
Figure 7: Satellite Imagery of the area showing Geolocation details of the house in Mui Tui (မို့တို့) village.

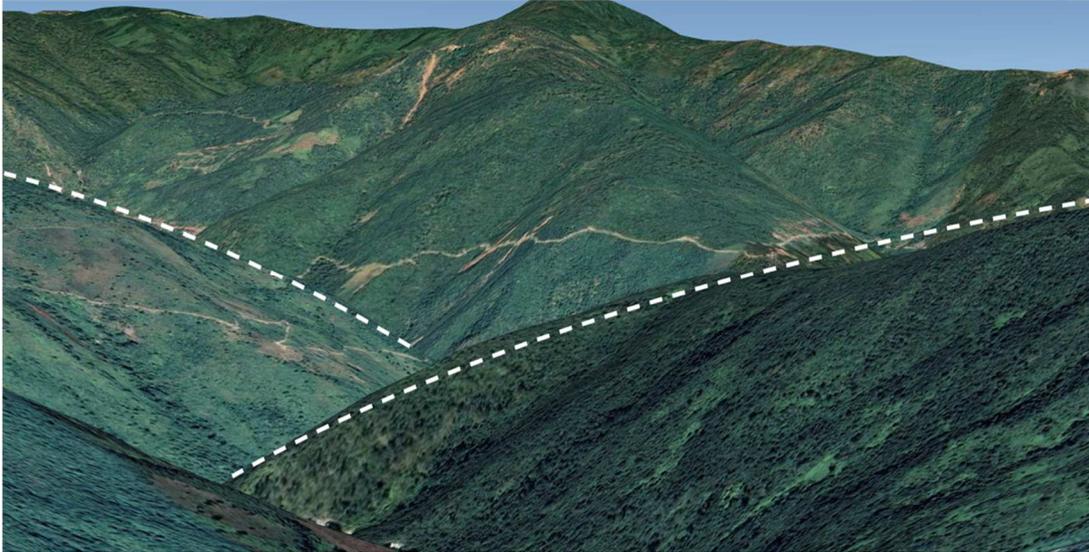
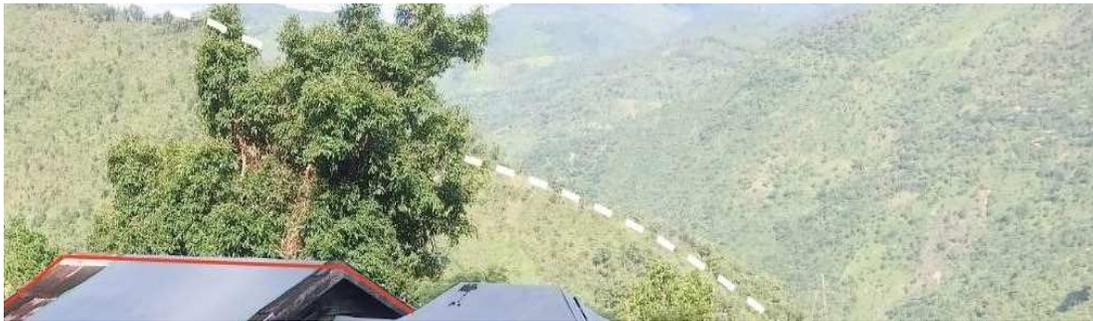
Figure 9: Heavily cropped image of the home of the injured child, where artillery injured him. Other images of this building contain bloodstains.

Myanmar Witness has geolocated images reportedly of the boys' damaged home to M'dat (မဒတ်) village. The coordinates and geolocation imagery have been obscured for privacy reasons. In Figure 9 and 10, Myanmar Witness has highlighted the structure's details and corresponding background features, such as the mountain slope and the small lane to the side of the house, that allowed for this geolocation.

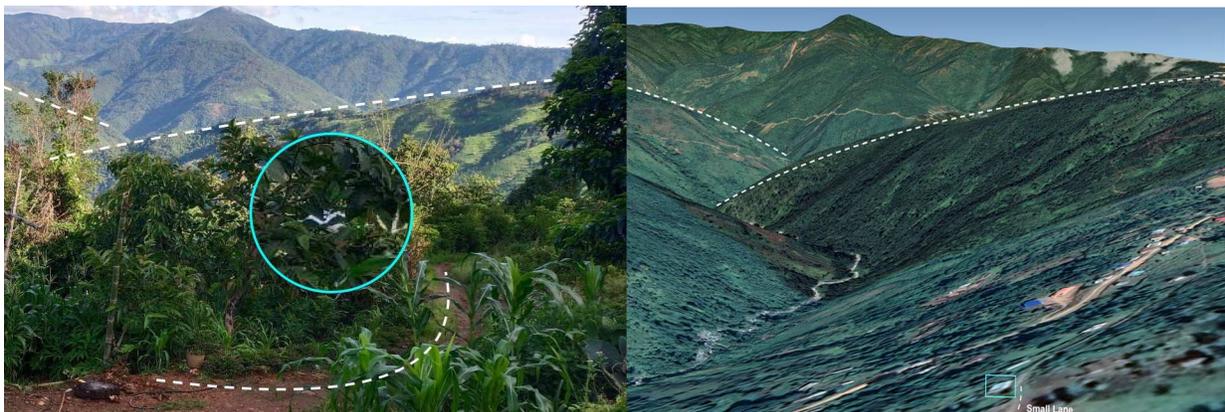
Figure 10: The small arching, roofing obscured by a tree, and mountain slopes that provided a match on Google Earth.

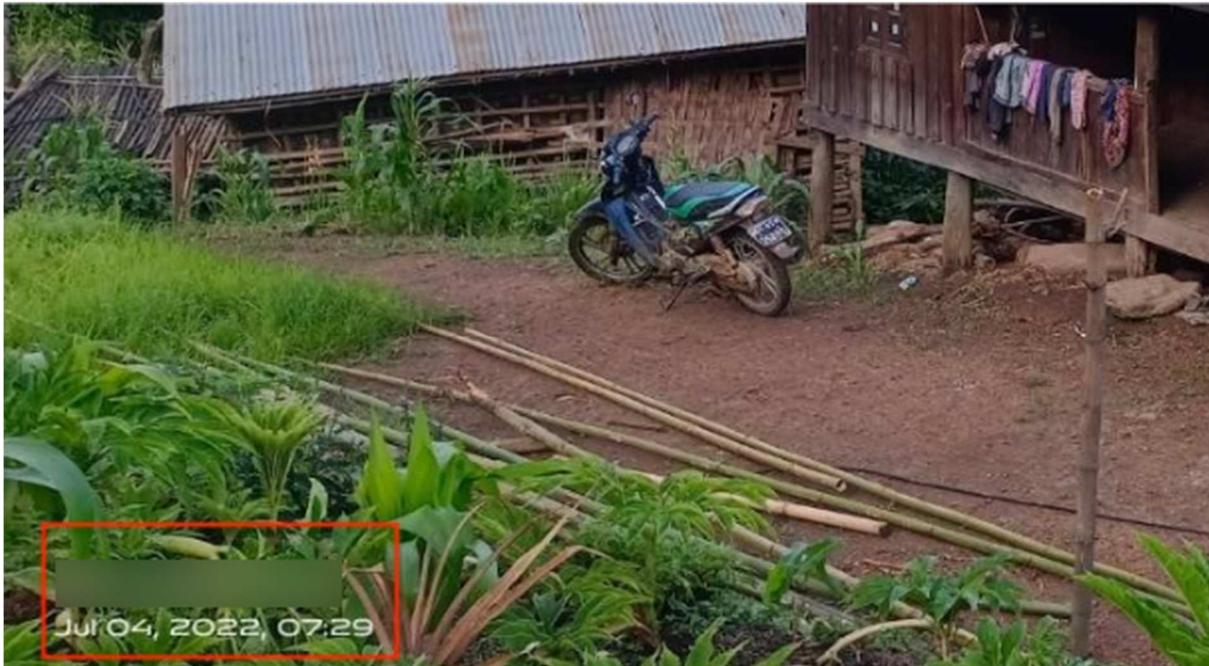
Figure 11: Image of the child's home, cropped by Myanmar Witness and name obscured for privacy reasons. No other modifications have been made to the image. A timestamp on the bottom left of the image indicates it was taken on 4 July 2022 at 0729 local time.

According to [CDF Mindat](#), the artillery shelling occurred at around 1000 local time on 29 June 2022. Due to the continued conflict around the area and also the lack of user-generated content, Myanmar Witness can not fully verify the chronolocation of the incident. The timestamp provided on images of the home was five days later than the actual event on 4 July 2022 (Figure 11).

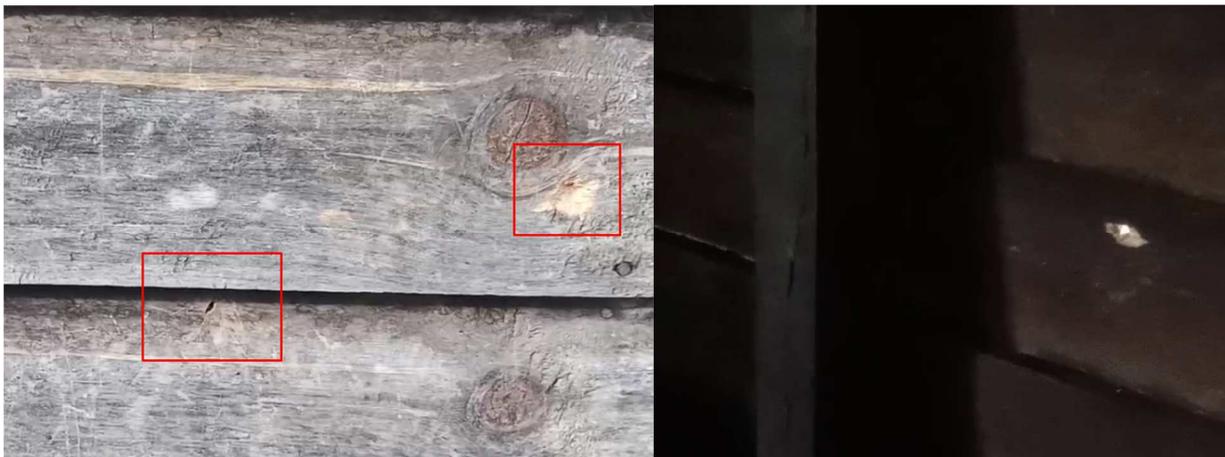
[Warning: Graphic] Myanmar Witness obtained footage of damage to the home - with a hole on the wooden wall that appears small on the outside but larger on the inside. This pattern of damage could indicate a lot of force upon entering the building to penetrate the wall, with a larger part of the damage from the inside.

Using ballistics and destruction analysis, Myanmar Witness has analysed video footage of the home with damage to the wood. The footage itself cuts out before it can be shown that the two holes featured - from the interior and exterior of the structure - are the same hole from different angles. However, it is possible to see that the wooden planks used to create the wall overlap with one hole just before an overlap on the wall of the interior and slightly overlap on the inside plank, where the plank with the hole overlaps the higher plank (Figure 12).

Based on the new exposed wood colouring - as compared to the rest of the dry grey wood - and the exit splintering on the inside, it does appear that something could have entered through the wood at significant speed. The wood walls appear to have a low density from the video footage, specifically from the interior shot of the entrance hole with wood splintering. From this low-density wood, it is possible the hole could have resulted from the fragments from the blast having penetrated the wood and hit the child alleged to have been inside at the time.

Figure 12: Two marks on the child's home, one having penetrated fully (left) and another with no entry penetration (right). The hole shows a small penetration entrance and a larger penetration exit with more splintering and fresh wood, with the rightmost pieces of damage exposing fresh wood on the wall, penetrating it but with no exit penetration on the side of the wall. This could indicate a fairly recent penetration with force into the wood to cause this kind of splintering, as well as multiple markings.

To the right of the initial penetration entry there appears to be another entry penetration, but no second hole inside. The second bit of damage is larger, with no visible penetration into the wood and no second hole visible inside (Figure 13). The fact the second entry penetration, which is much larger, does not have a second exit penetration visible on the inside of the home could suggest that the fragments were, instead, caught by the wooden column to the left of the first hole on the interior of the structure.

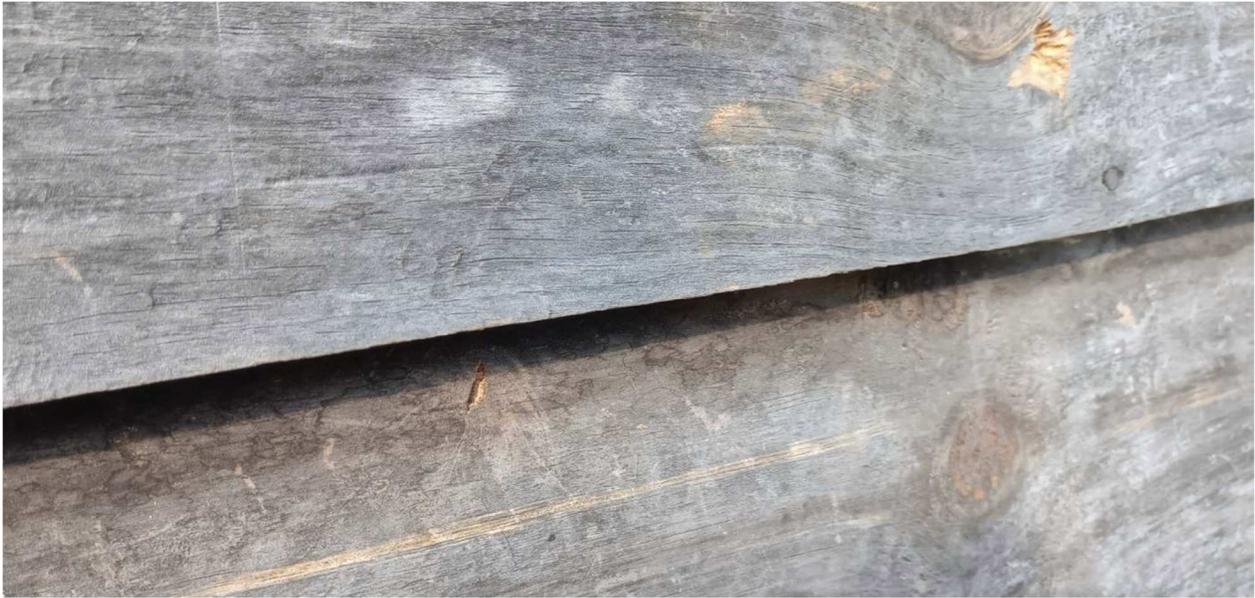
Figure 13: Side-on images of the damage, showing two entry penetration marks, exposing new wood, with one being higher and larger than the other.

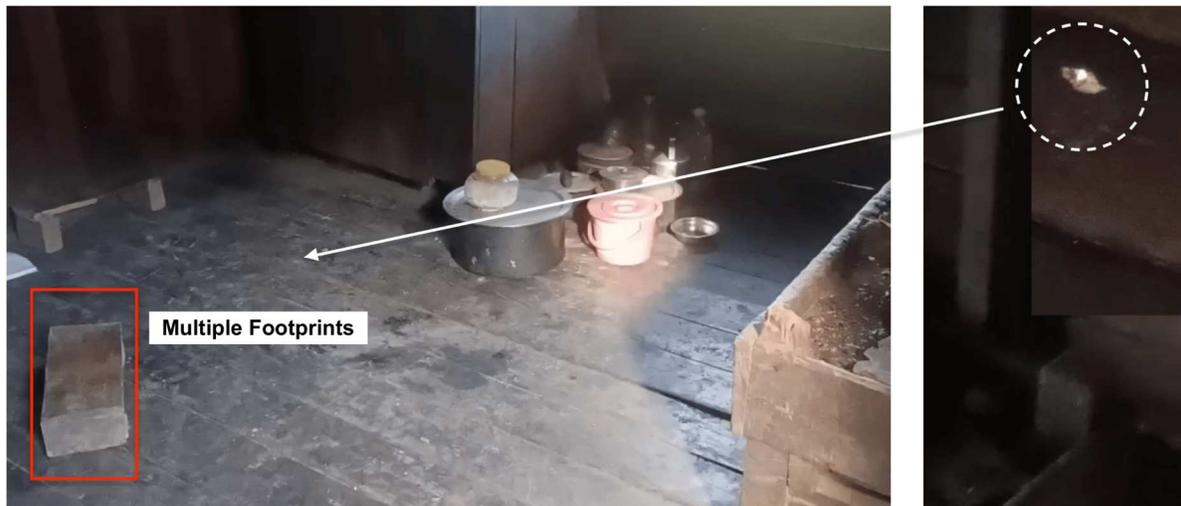
Figure 14: Images of the inside of the home, where multiple footprints can be observed which could suggest there was recent activity in the home. The arrow here represents that the hole in the wall potentially aligns with the stool in the image (red box) - where the child could have been seated at the time of this incident - especially if the child was, as reported, eating at this time.

Myanmar Witness has also analysed video footage of the inside of the home (available on request). The individual in the footage claims the young boy was eating rice for breakfast when hit and killed. The hole in the wooden wall aligns with the position of the stool in which a child could have been sitting. Footprints on the floor could demonstrate the recent presence of an individual in the home.

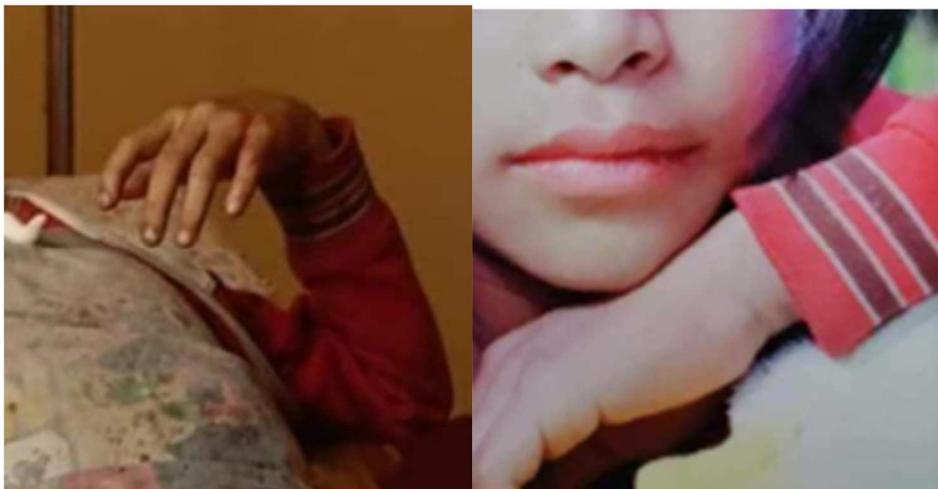
Figure 15: Images of the two boys wearing the same jacket - potentially indicating their relationship as siblings.

Myanmar Witness was also provided with an image of the child while alive. This image and the deceased body appear to share aesthetic facial similarities. Due to the graphic nature of the images, the link to such images are available on request. The child injured in Mindat the month before appears to be wearing the same jacket as the deceased child in these photos allegedly from before death - further indicating they were related (Figure 15). The prayer beads previously mentioned in the deceased child's hands are very aesthetically similar to those in the image of the child alive (Figure 16).

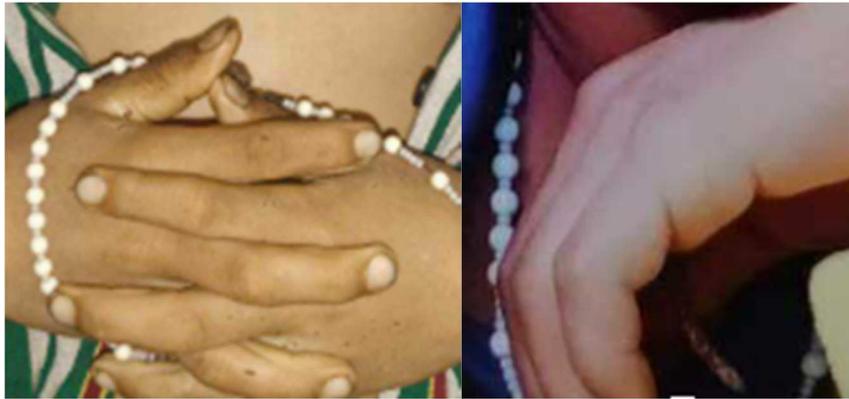
Figure 16: Comparison of the aesthetic similarities between prayer beads present in photos of the deceased and those seen being worn by the child while they were alive.

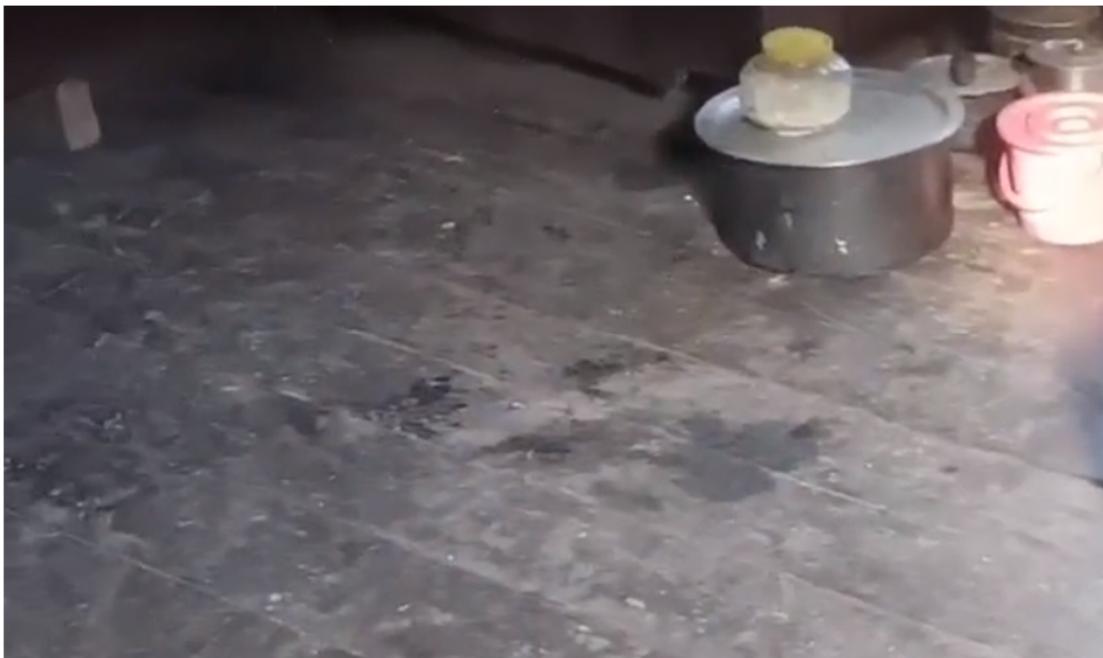
There appears to be unusual staining on the ground in the home (Figure 17). This could be related to the spilling of possible liquid or food items or, potentially, blood. Some of the patterns appear to be droplet or splashing type marks, with some being darker than others - which could suggest newer and older stains or potentially different types of staining. The staining on the wood could be pre-incident or from the attack. Regardless, there is not enough evidence from the inside of the home alone to suggest these stains are, in fact, blood.

Figure 17: In a frame of a video of the child's home, there appears to be darker staining on the wood.

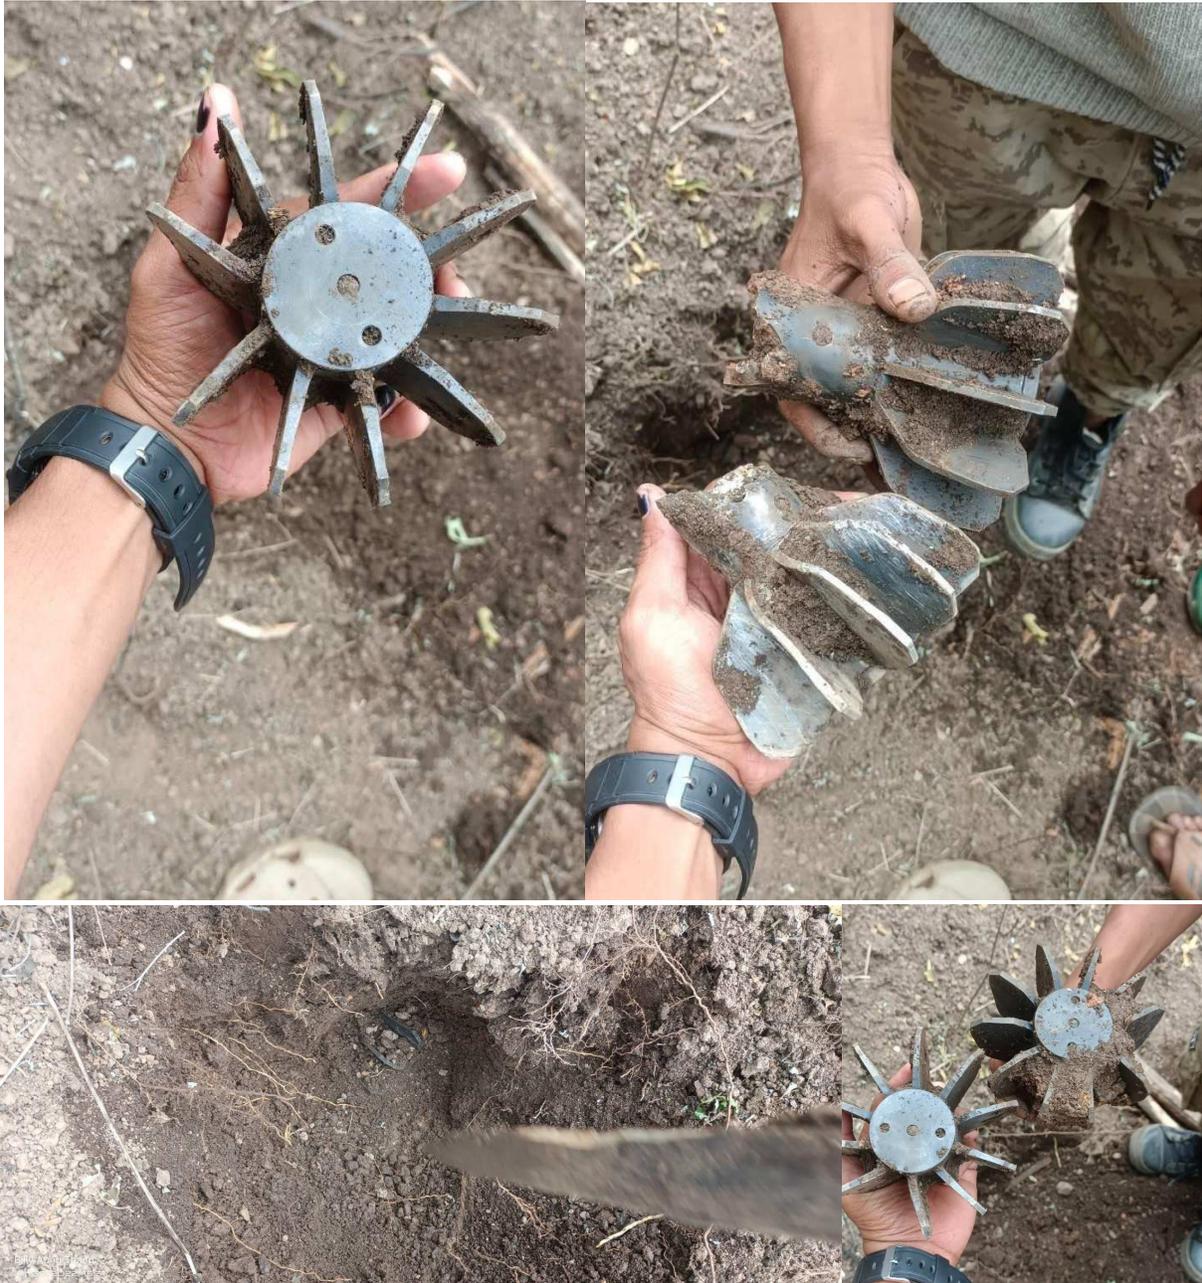
Figure 18: Images provided to Myanmar Witness alleged to be the remnants of the ammunition fired towards the village by the military.

Myanmar Witness analysed footage of ammunition reportedly found at the scene of the attack to assess if this was consistent with military involvement.

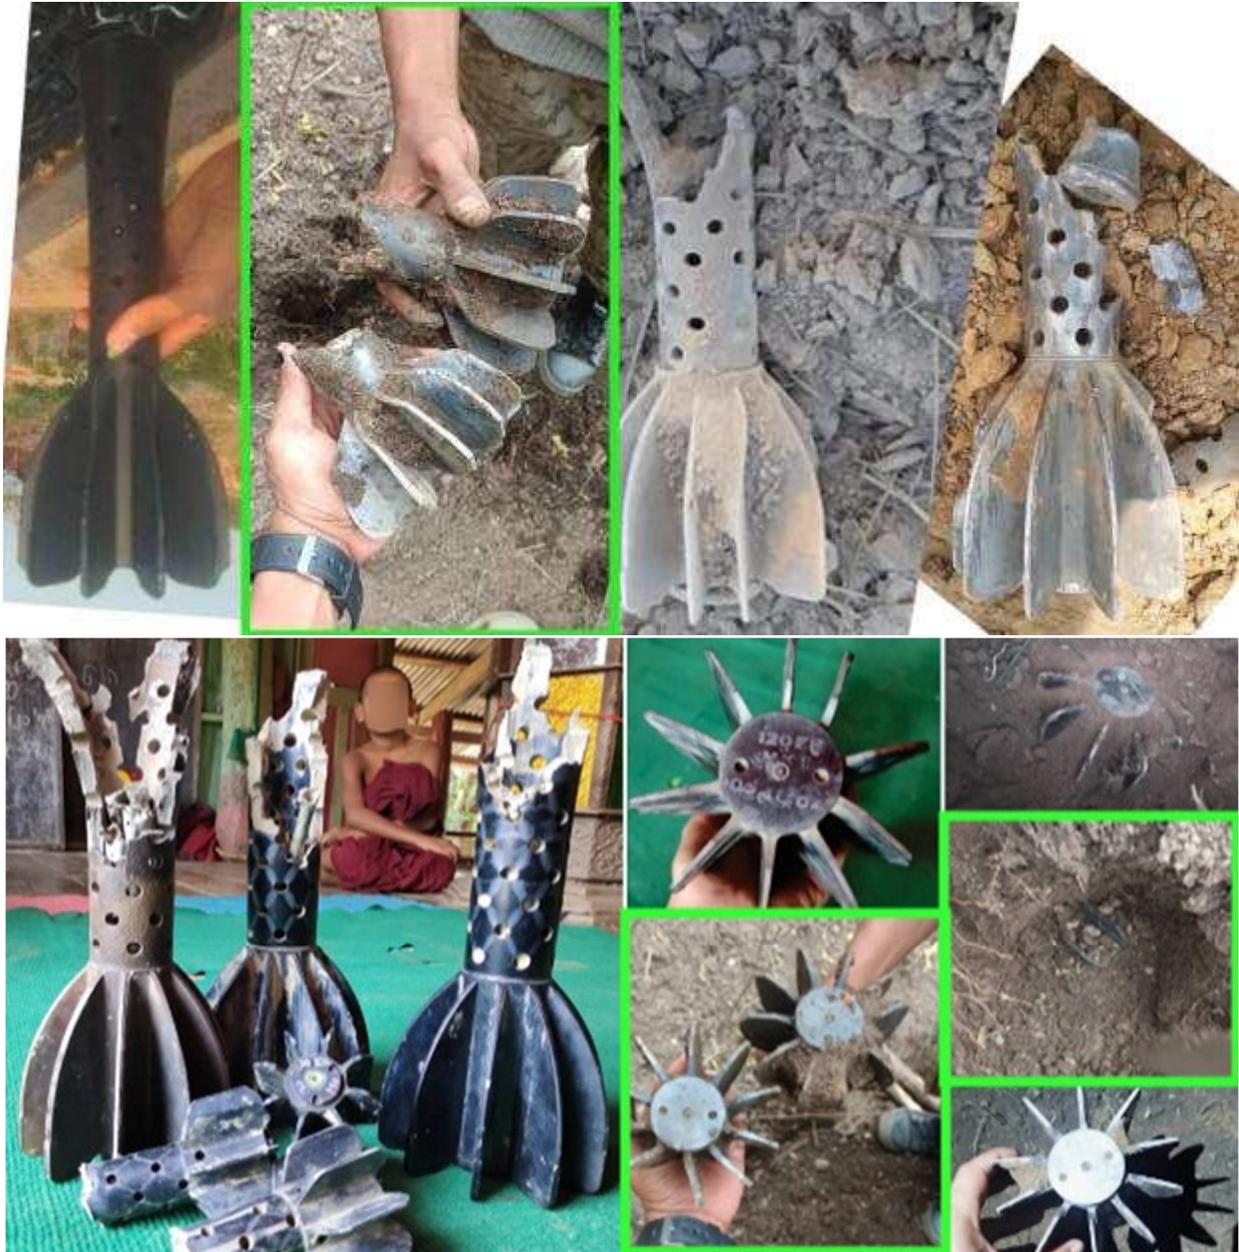
With the help of reference images, Myanmar Witness has compared these images, noting how the threaded tailfin, slanted fins, and overall size of the pictured munitions match with a 120mm locally-produced mortar round (Figure 19).

Figure 19: Two images uploaded to social media alleged to be from the incident [highlighted in green] compared to reference images of 120mm mortar rounds.

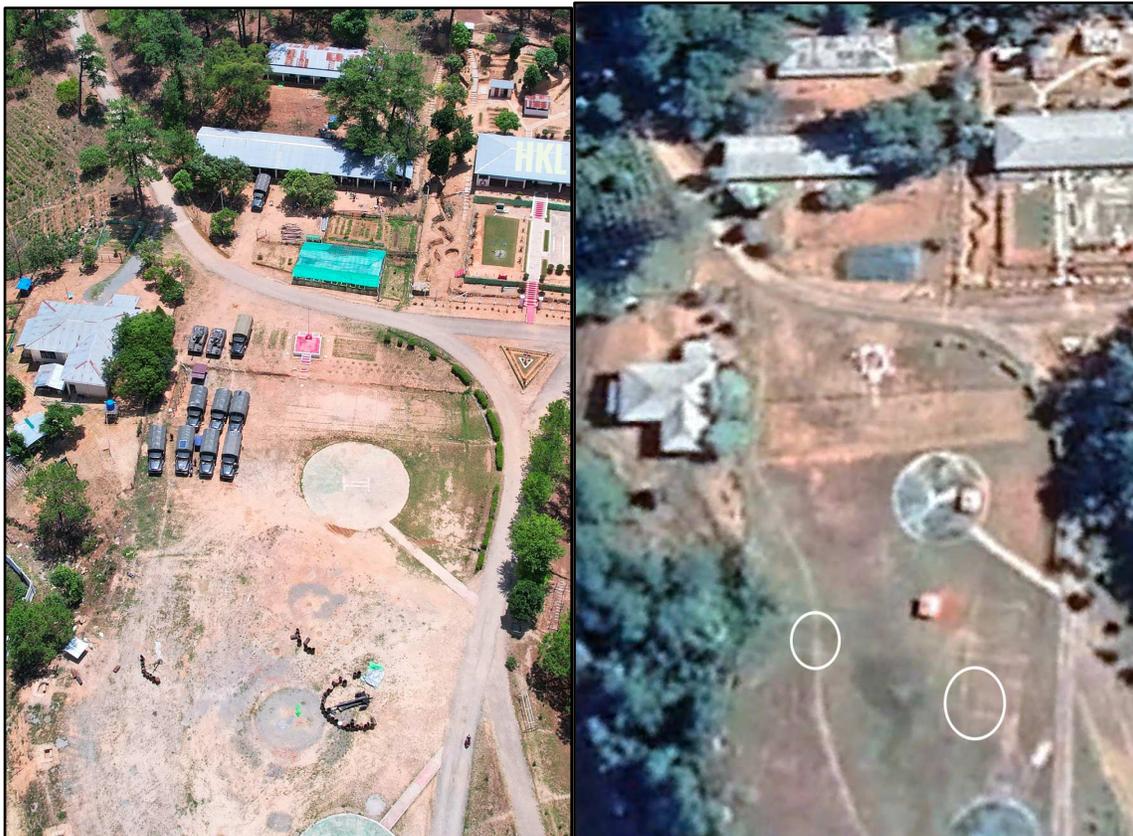
On the premises of the military base of the 274 Light Infantry Brigade [21.373507, 93.935312] on drone images posted on 15 May 2022 it is possible to spot a mortar, deployed and aimed towards north-west - however, this is not the direction of M'dat (မဒတ်) village (Figure 21). Given the significant distance and limited dimension of the mortar, at this point, Myanmar Witness is not able to identify its exact model and type.

Figure 21: Image of the military convoy in the LIB 274 military base with objects' firing positions highlighted with two white circles.

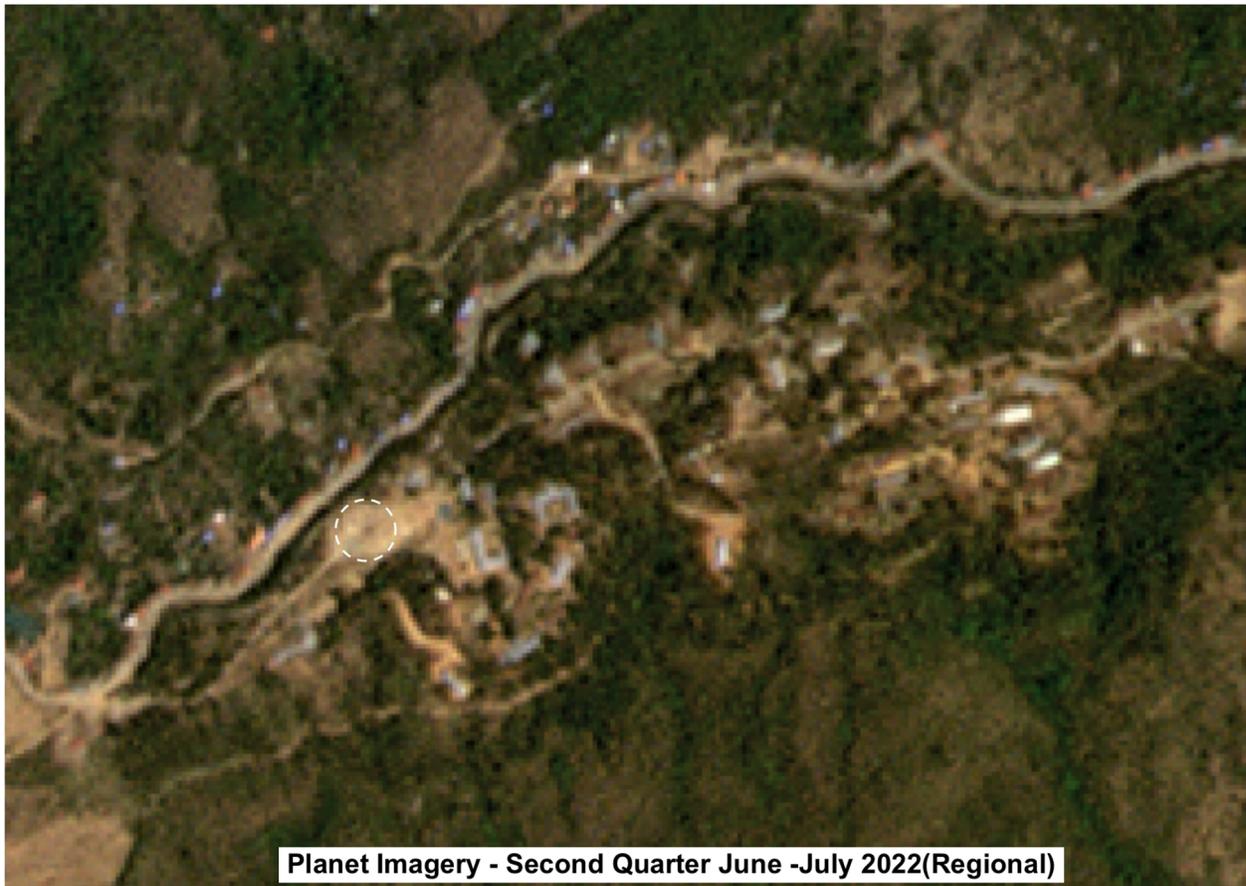
Planet Imagery - Second Quarter June -July 2022(Regional)

Figure 22: Planet Imagery of the LIB 274 military base taken between June-July 2022. The image shows the Howitzer and Mortar are still in position post-incident. This image has been edited by adding a small dotted white circle to indicate the munition position. No further manipulation was conducted.

The second artillery piece visible on the premises of the firing ground is a Soviet-made D-30 122mm howitzer. Howitzers, however, do not fire shells that look like the one found on the scene of the incident and analysed above.

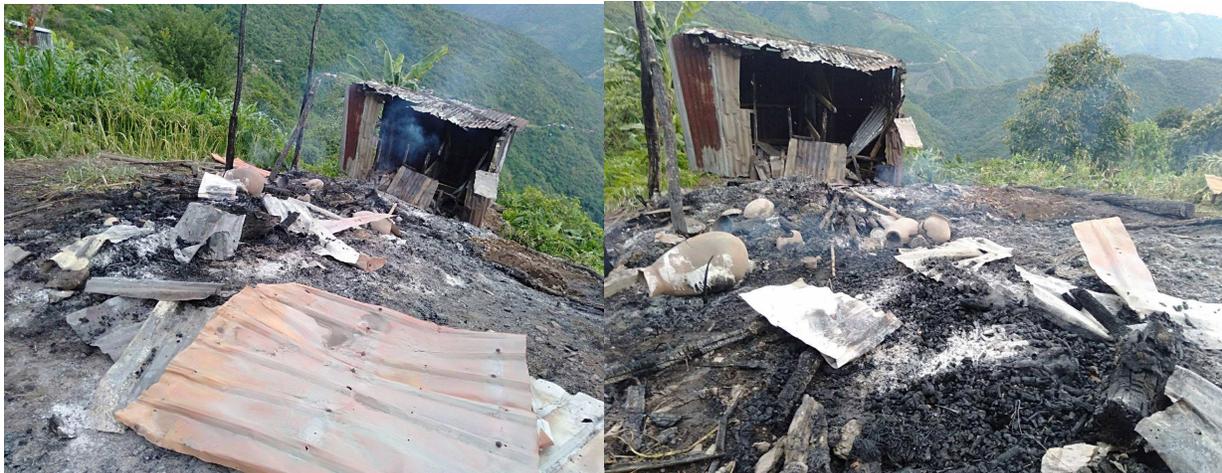
Figure 23: A structure appears to have been destroyed in Kyam Ain Nu (ကြာအိမ်နူး) village, there appears to have been a structure destroyed initially and another structure that was part of the original is still standing - likely a toilet or shed.

Myanmar Witness also documented another house that had been destroyed by the artillery at the same time as the event in M'dat (မဒပ်) on 29 June 2022. This structure is alleged to have been destroyed in Kyam Ain Nu (ကြာအိမ်နူး) village, Mindat Township (မင်းတပ်မြို့နယ်). Media agency [Zalen](#) posted images of a destroyed structure and the mountain line suggests a possible location of the structure. Myanmar Witness also received a file submission which provided images of the same location (Figures 23 and 24).

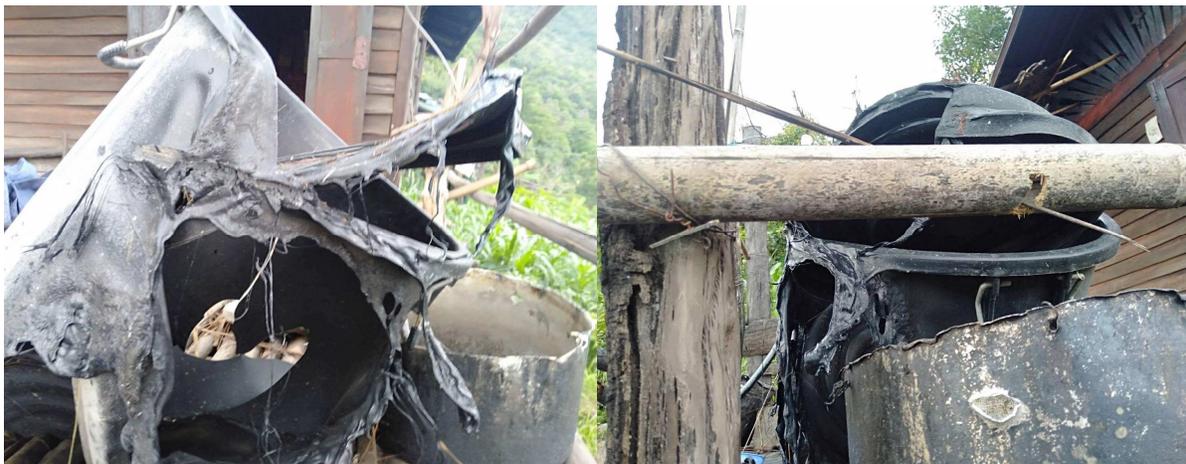
Figure 24: Unverified damage to a plastic basket that appears to have been melted due to fire or as the direct effects of artillery hit.

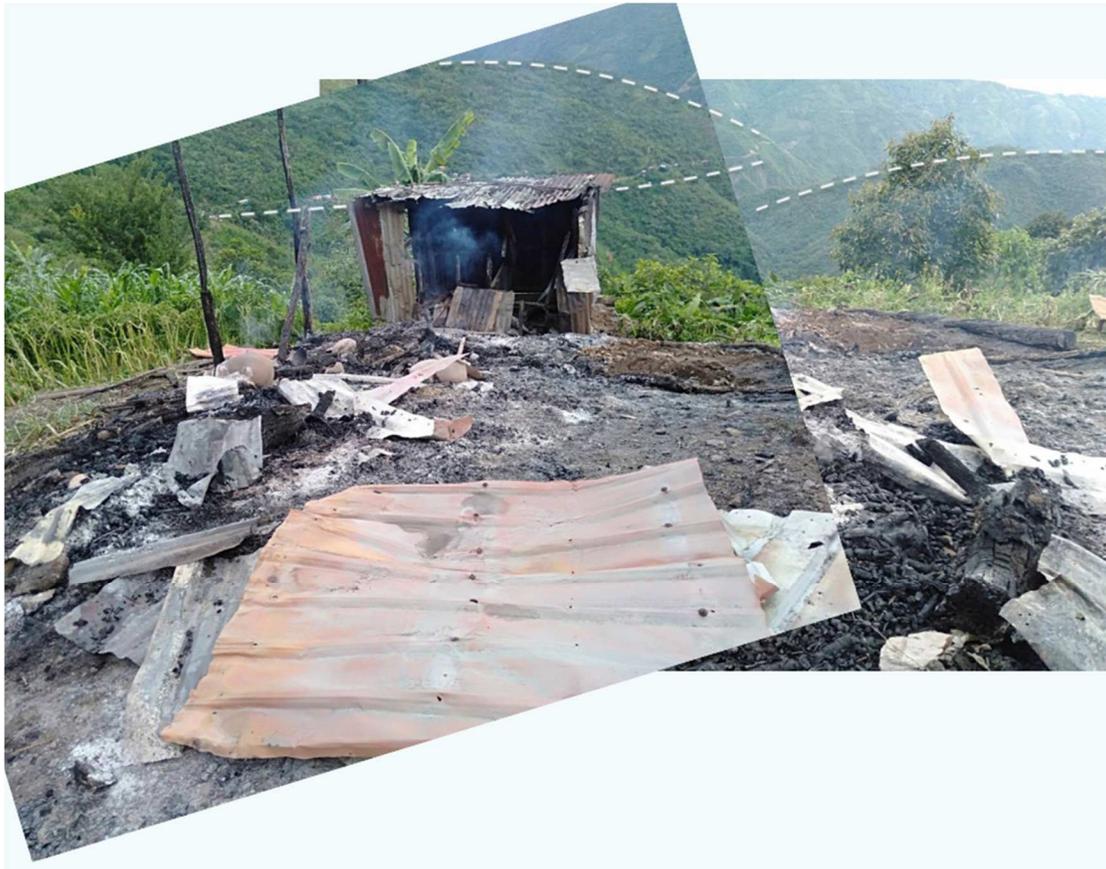
Figure 25: A composite image of the photos, demonstrating mountain lines and pathways visible in the background of these images, as well as structures dotted north-west of the structure.

Myanmar Witness has identified a probable location of the destroyed structure to Kyam Ain Nu (ကျာအိမ်နူး) at around 21.319842, 93.890447 (Figure 25 and 26). The structure is potentially a home; the image appears to show a smaller, standing structure - likely an outhouse to the original structure - which could be a toilet or shed. Another similar structure can be seen to the right of the image. On Google images, the structures appear to be very close to one another, indicating they are part of the same structure and this destroyed building was potentially a civilian home (Figure 27). While the identified location is consistent with the images, it was not possible to ascertain with 100% certainty that this is the exact location.
