SEQUEL EVENT INVESTIGATION

Killed in Mindat Township

Civilians, including children, were allegedly hit with artillery in different incidents

REPORT BY MYANMAR WITNESS, 3 October 2022

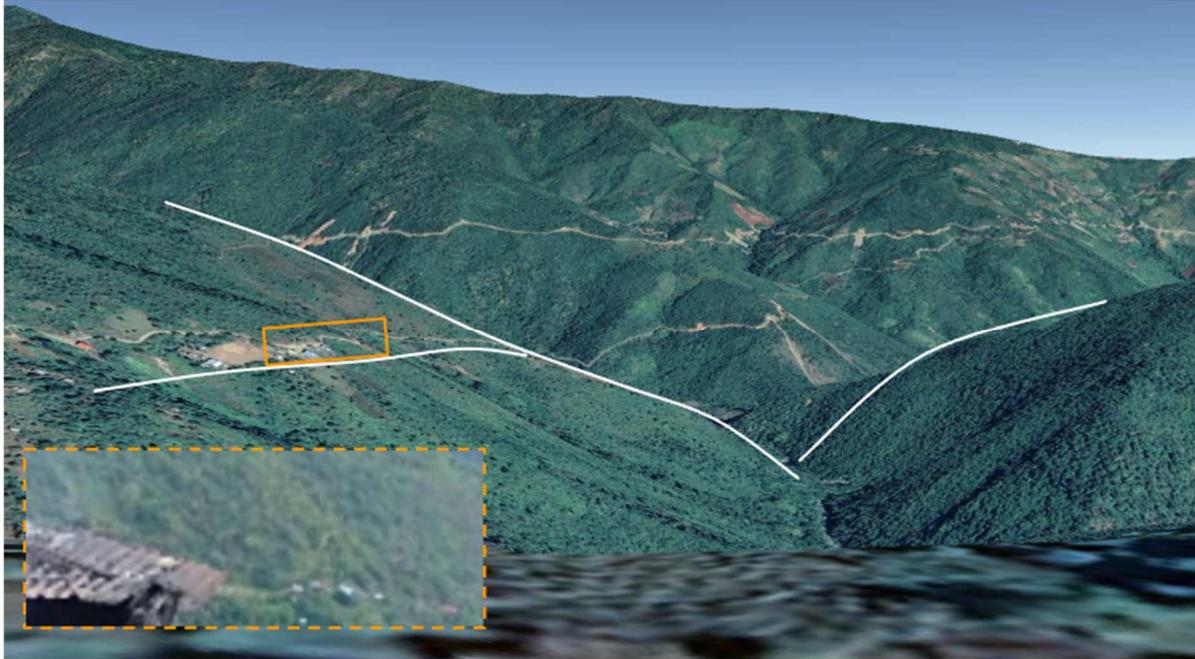
Figure 26: Google Earth imagery demonstrating similarity in the background mountain range, valley, and buildings.

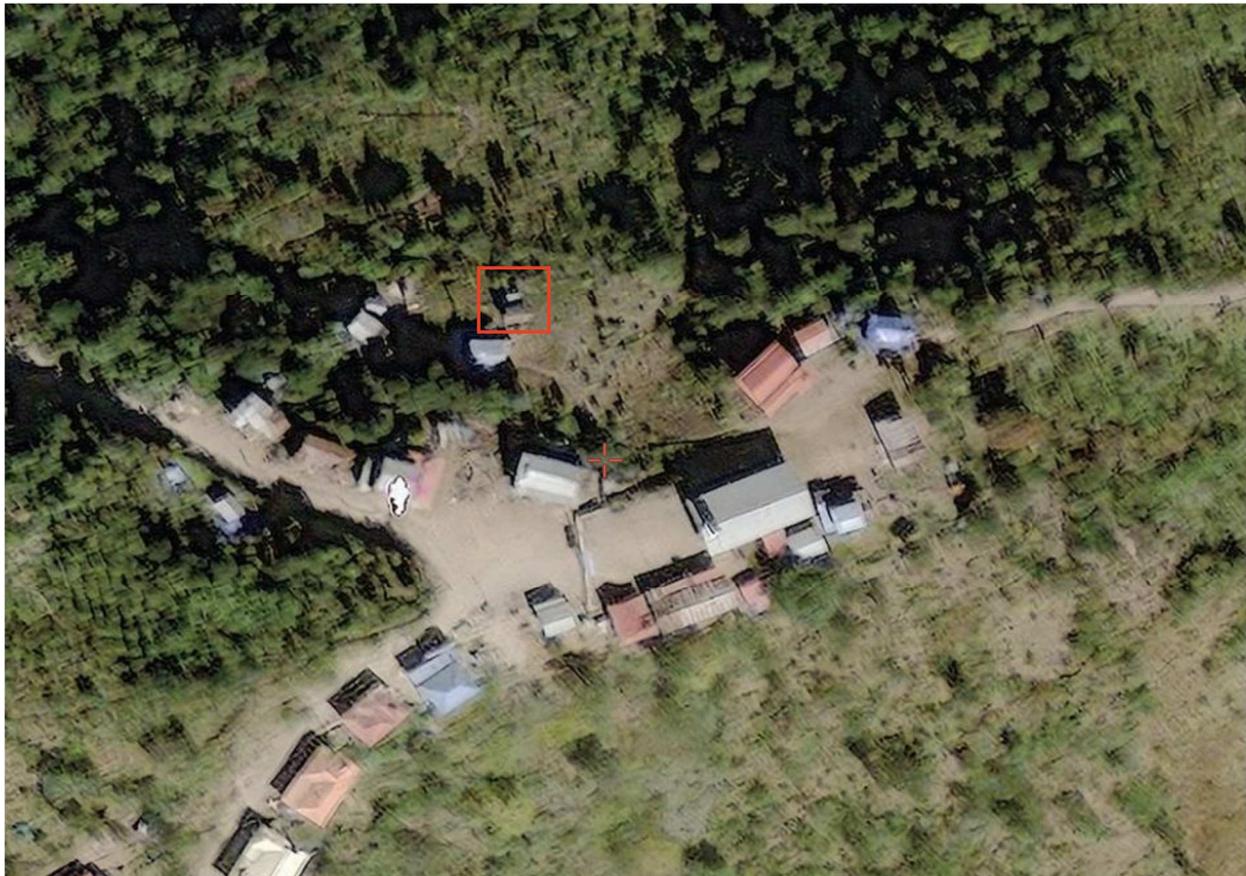
Figure 27: Old Satellite Imagery of the possible destroyed structure area located around Kyam Ain Nu (ကျာအိမ်နူး) Baptist Church.

There is a lack of other details to confirm that this image was taken on 29 June 2022. Due to the weather conditions in the mountainous Chin regions, satellite imagery has been difficult to use in order to confirm damage to the structure in this area or indicate a fire resulting from the alleged artillery shelling.
